FINAL REPORT
VTRC 06-R31

BEST PRACTICES FOR THE REHABILITATION AND MOVING OF HISTORIC METAL TRUSS BRIDGES

Figure 1. Route 746 Bridge Over Calfpasture River at Goshen, Virginia

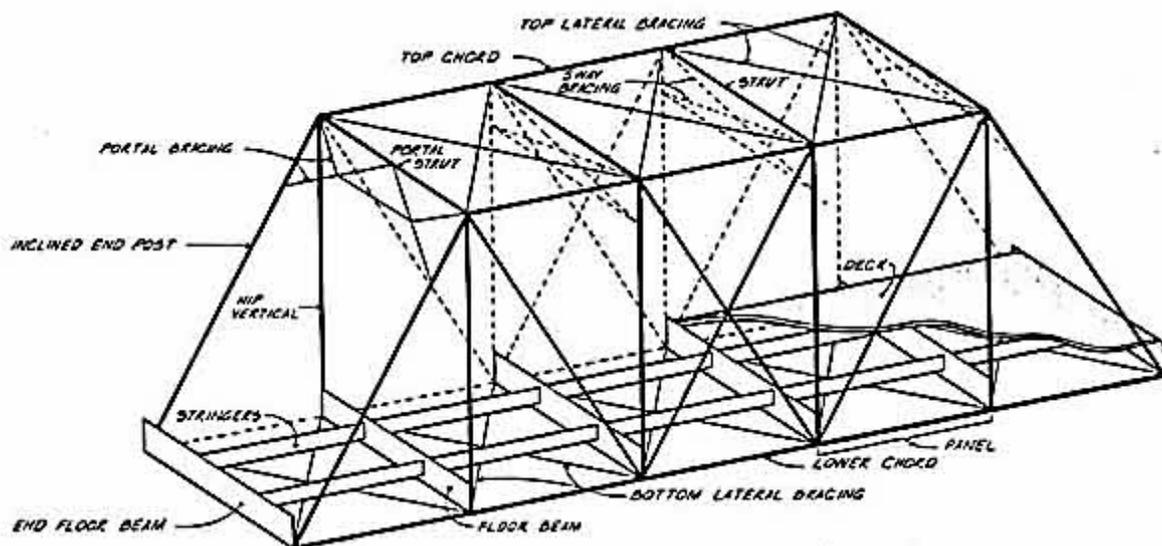
Figure 2. Components of a Typical Truss Bridge. *Source:* Historic American Engineering Record. Trusses: A Study by the Historic American Engineering Record. HAER T1-1. (Poster). National Park Service, Washington, DC, 1976. Reprinted with permission.

Replacement of the counters, secondary diagonals shown as dotted in Figure 2, was required for compliance with the AASHTO specifications (AASHTO, 2002). Counters are adjustable diagonal members that serve to add rigidity to the truss. They are loaded only by the passage of the live load and prevent stress reversal in tension members. Usually, counters are formed from square or round bars and terminate with eyes at the pin connections. Loop, or loop-welded, eyes, such as those from another structure shown in Figure 17, are formed by bending the bar to form a loop and forging (welding) the end into a notch in the straight section of the bar. Failure of loop bars at that point has been noted during inspections of historic truss bridges, and their use has long been prohibited (Urquhart and O'Rourke, 1930). The eyes in the replacement counters, Figure 18, were formed by welding the end of the counter into a notched plate in which the pin hole is drilled.

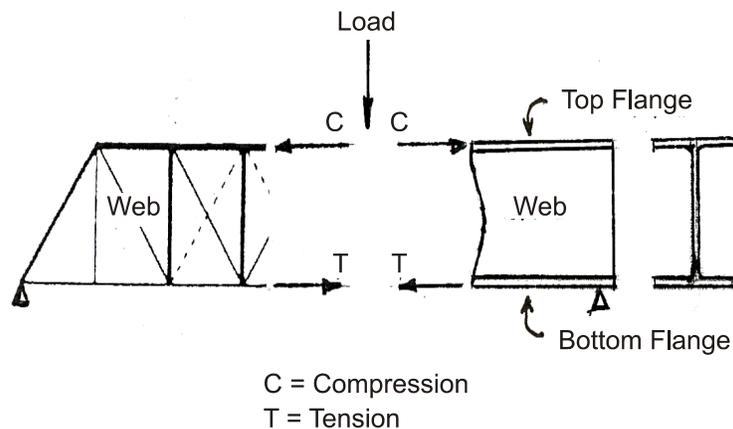
Figure 3. Truss-Beam Analogy

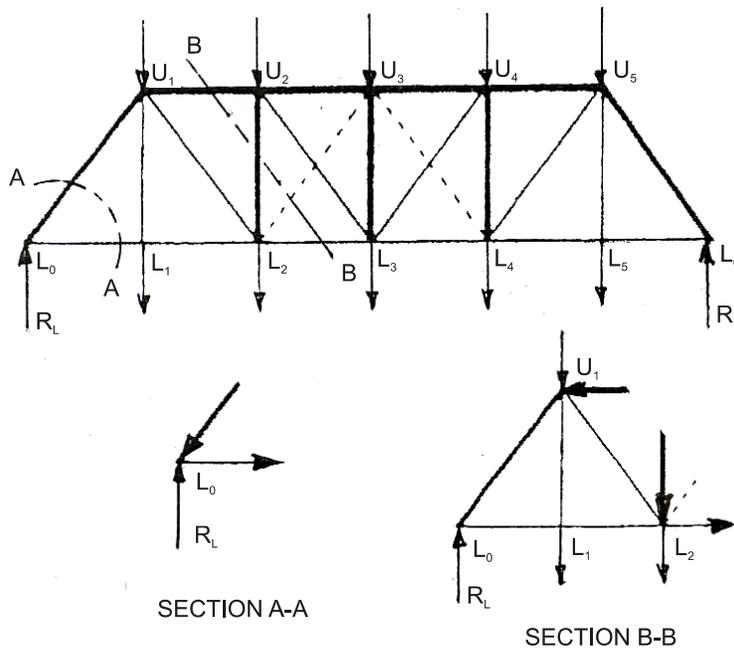
Figure 5. Procedures for Analysis of Truss Under Dead Load

reactions R_L and R_R are equal. The method of joints is most easily demonstrated at the left end of the truss, section A-A. For the algebraic sum of the vertical forces to equal zero, the upward reaction, R_L , must be balanced by the vertical component of the downward (hence, compressive) stress in the end post, $L_0 U_1$, since member $L_0 L_1$ has no vertical component. Similarly, the stress in the horizontal member $L_0 L_1$ must be equal to the horizontal component of the stress in the end post $L_0 U_1$. For equilibrium, the member $L_0 L_1$ must be in tension.

The Pratt truss in Figure 4 is shown under its dead load in Figure 5. Since the loads are distributed symmetrically at the upper and lower panel points as explained earlier, the end

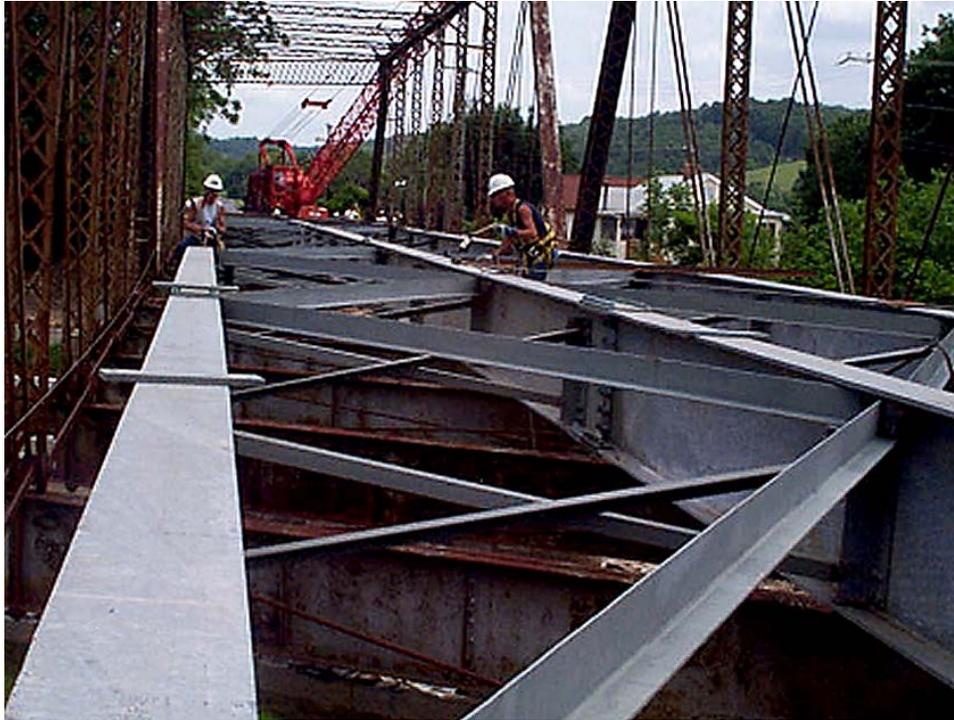
Figure 6. Falsework Beams during Installation

The Calfpasture River at Goshen flows rapidly, carrying runoff from a substantial mountainous drainage area. During frequent floods, the river carries significant amounts of debris that would pose a threat to temporary supports located in the river or the adjacent flood plain. For this reason, the Staunton design team decided to use beams available in a district storage yard to construct a specially designed interior falsework beam system, shown in Figure 6, consisting of three lines of continuous girders as a primary means of support throughout the job. The falsework beams were supported on blocks on the floor beams of the bridge and on three temporary bents, two at the abutments and one at the pier. They were designed with splices as required to form a continuous beam across the bridge, and a heavier section was used to resist negative moment over the pier. Between the lines of falsework beams, cross frames resisted torsion in the support structure during disassembly, and lateral bracing supported the compression flanges of the girder lines. Drawings and other information on the support system, including the design of the steel falsework bents, and other structural details and procedures described elsewhere in this report can be found on the project plans (VDOT, 2000a).

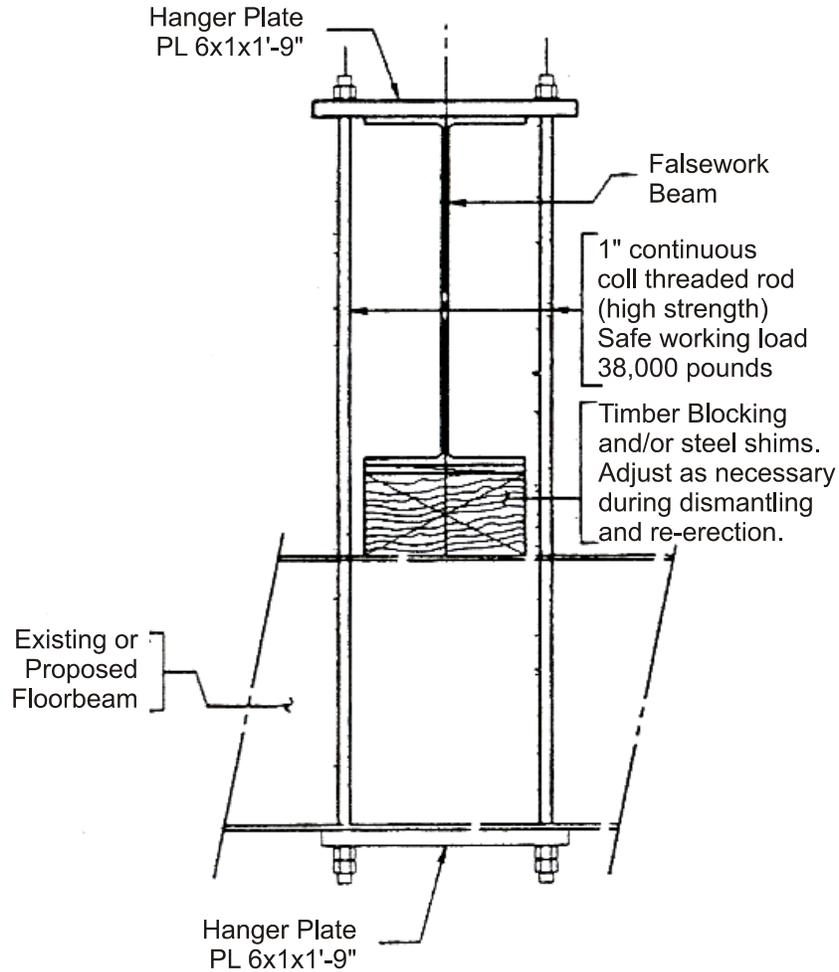
Falsework hangers (Figure 7) support the floor beams at their intersections with the falsework beams. They had to be tightened to a snug fit before any loads could be transferred to the falsework beams and adjusted as necessary to remain snug during dismantling and re-erection operations. Once the hangers were tightened and the loads transferred, the two simply supported (independent) truss spans acted as a two-span beam continuous over the central pier. Thus, loads on one of the spans have an effect on the deflection of the other, and this had to be considered during operations to unload or reload the bridge. Re-erection of the restored trusses was performed symmetrically from the center pier toward the two abutments.

Figure 7. Falsework Hanger

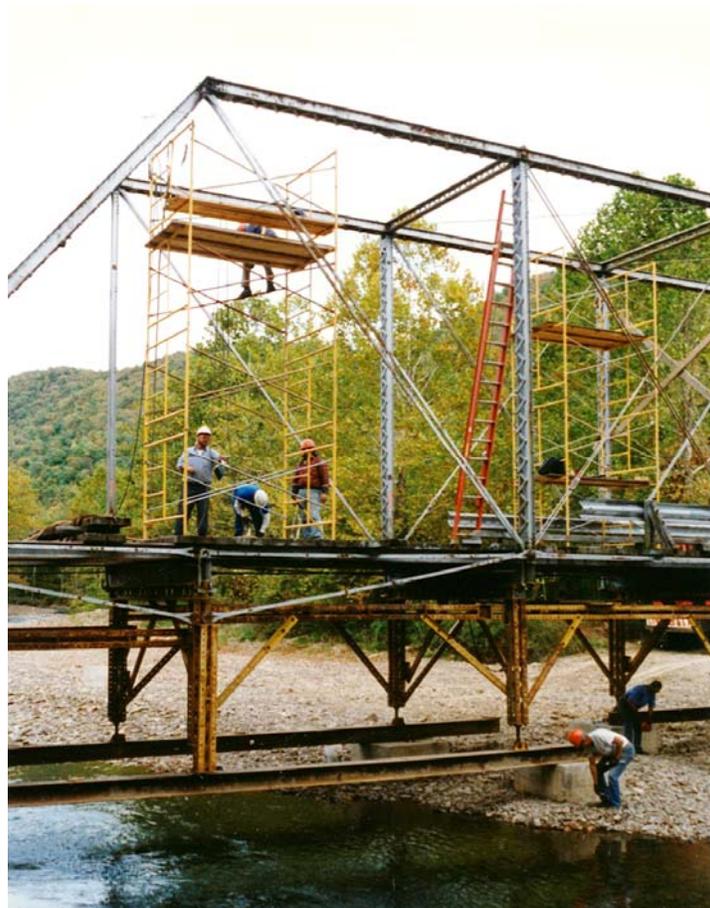
Figure 8. Falsework System Supporting Each Panel Point

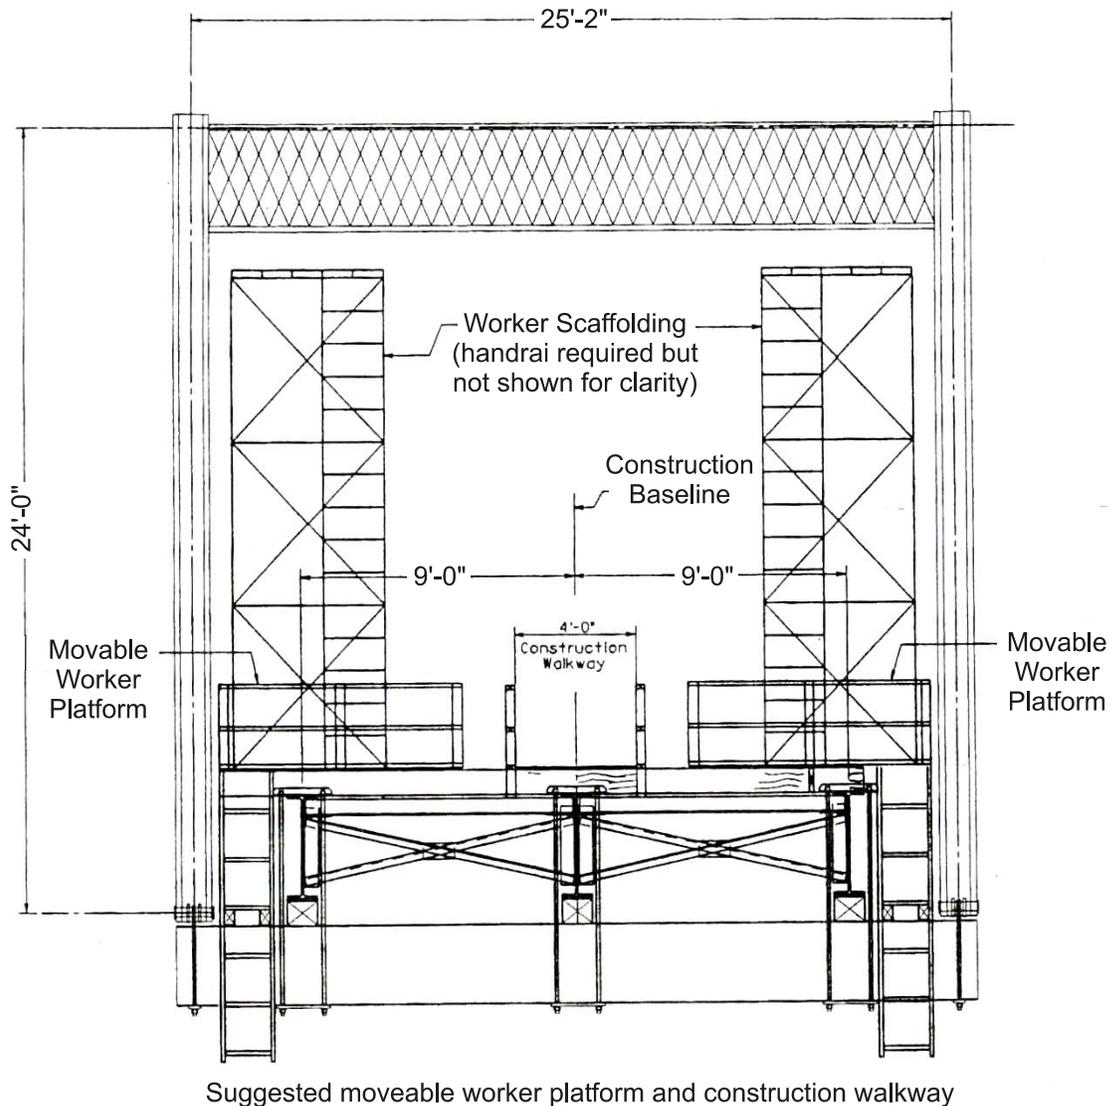
Figure 9. Suggested Platform for Worker Access Travels Along the Three Falsework Beams. Falsework hanger assemblies supporting floor beams are also shown.

To ensure the safety of the bridge against overloading during removal and re-erection operations, the plans also included the suggested movable platform and walkway for worker access, shown in Figure 9. Alternate methods could be submitted for approval by the contractor subject to limitations of 50 pounds per square foot for dead load and 50 pounds per square foot for construction live load. The suggested work platform was approximately 8 feet wide by 15

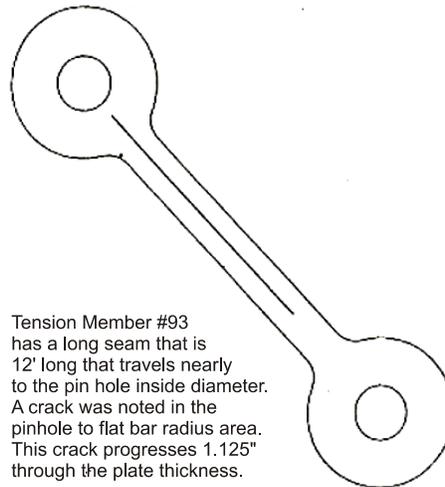
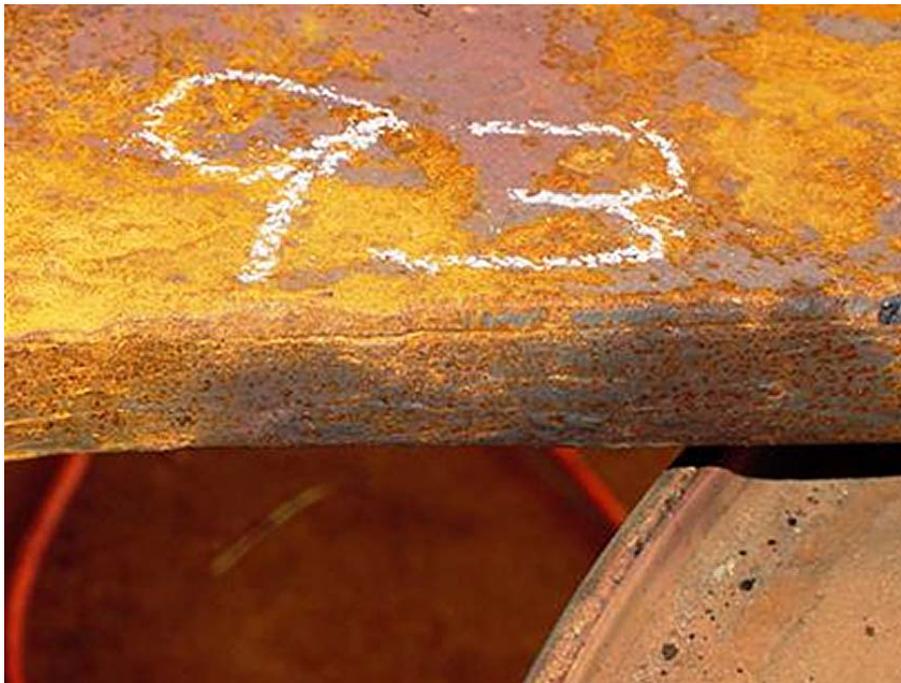
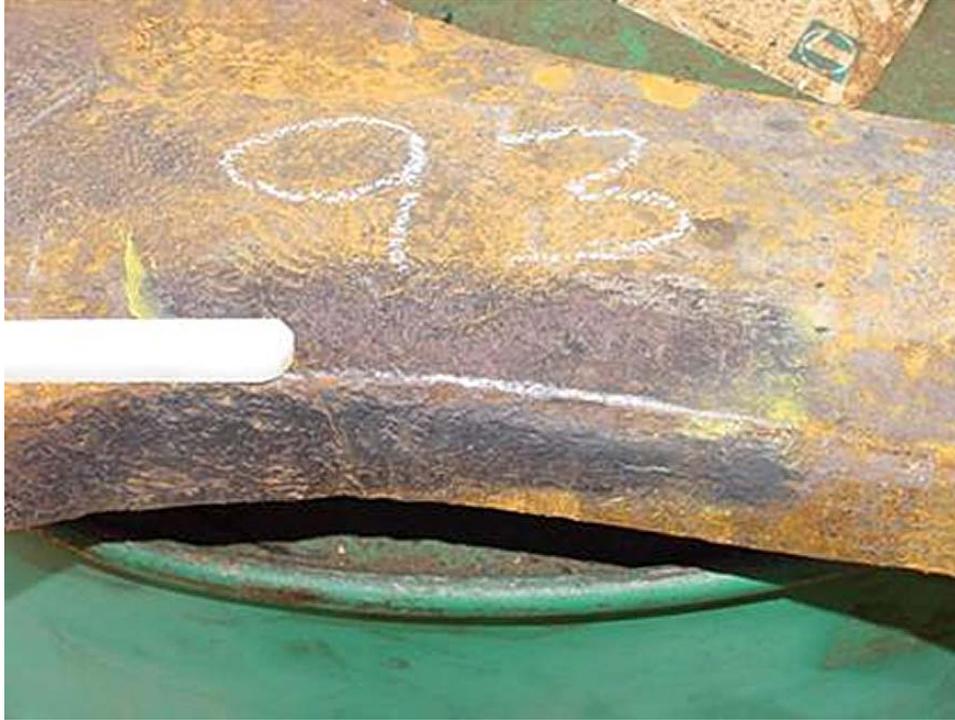
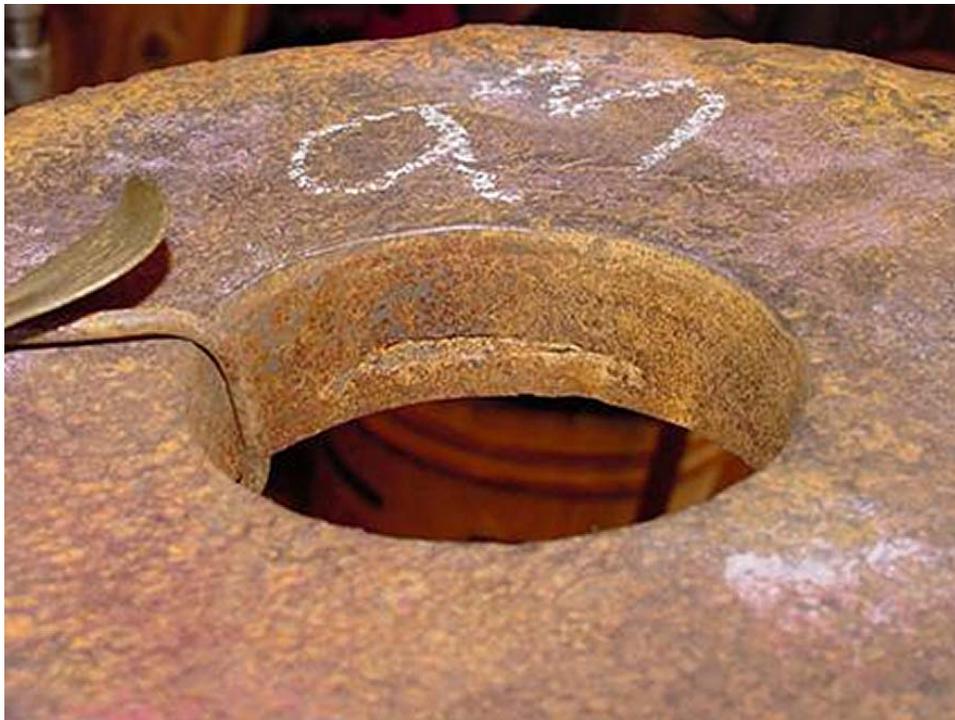
During this inspection, several surface defects were noted in the fracture-critical members. Most of the long surface seam indications can be classified as stringers of non-metallic inclusions. These indications follow the grain flow in forgings. Several cracks were noted on the inside diameter wall in the pinhole area. These cracks have originated from laminar type defects and have progressed to the surface of the part. These indications are a concern for the inspector and may increase in magnitude during the 900°F zinc coating galvanizing process. This inspection was performed in accordance with ASTM A275 Standard Test Method for Magnetic Particle Documentation of Steel Forgings.

A diagram and description of the defects disclosed in eye bar 93 during the magnetic particle tests are provided in Figure 10, and photographs of defects in the bar are shown in Figures 11 through 13. Similar defects were found in eye bars 99 and 100, as shown in Figures 14 through 16.

Figure 10. Defects Disclosed in Lower Chord Eye Bar 93 During Magnetic Particle Testing

Figure 11. Longitudinal Seam Edge of Bar 93

Figure 12. Crack (at Tip of Pointer) in Transition Radial Area on Edge of Bar 93

Figure 13. Seam in Surface of Pin Hole, Eye Bar 93

It was surmised that the laminar defects in the wall in the pin hole were indicative of fabrication by piling and welding. The resulting cracks in the pinhole wall were troubling, and the presence of those and other defects in the fracture-critical lower chord members, combined with heavier loads on the reconstructed bridge, led to a decision to replace all of the lower chord members.

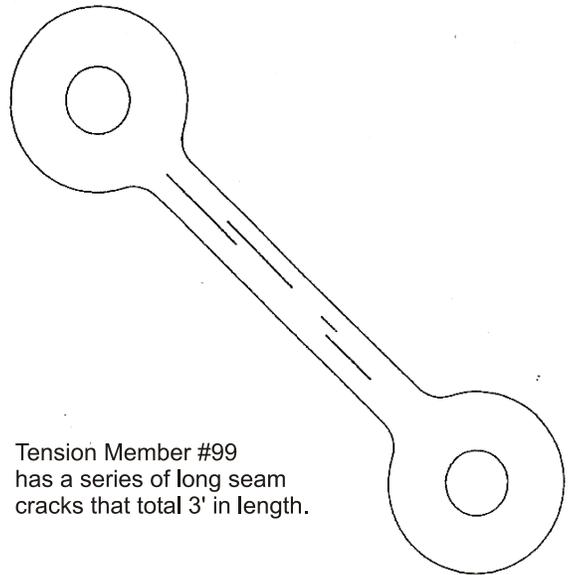
Tension Member #99 has a series of long seam cracks that total 3' in length.

Figure 14. Defects Disclosed In Lower Chord Eye Bar 99 During Magnetic Particle Testing

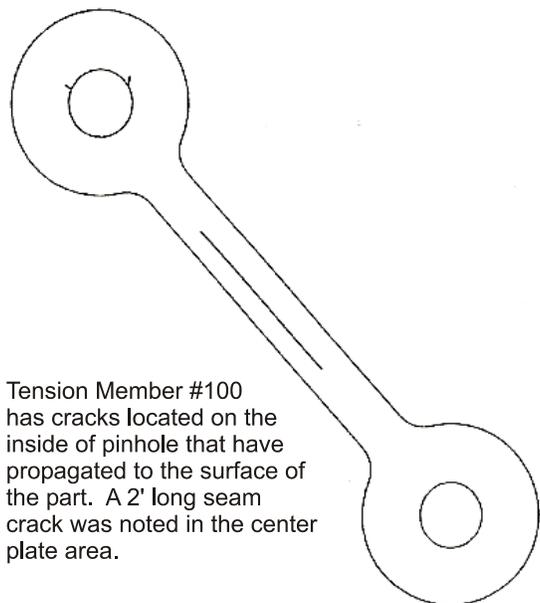
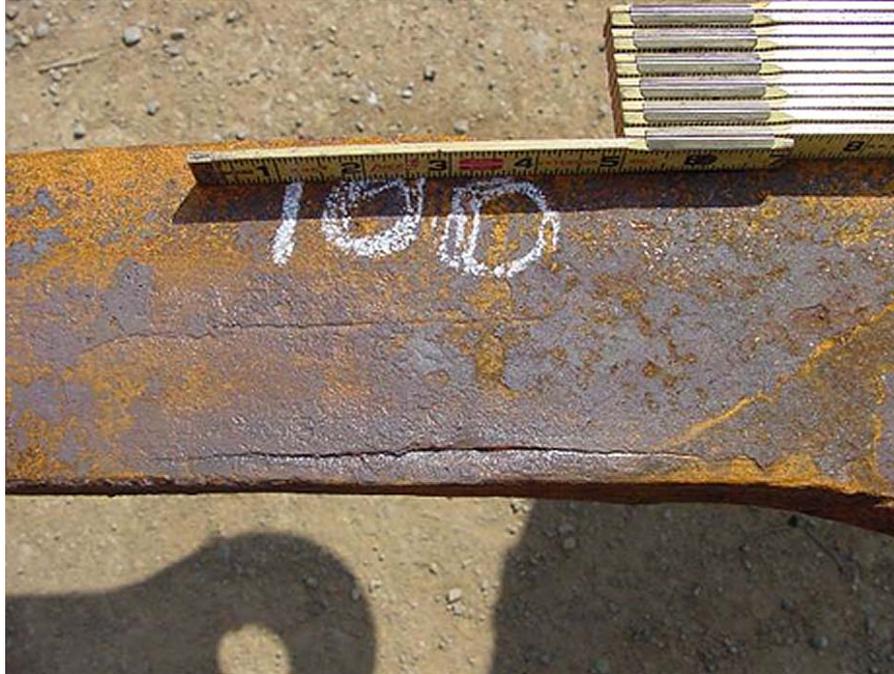
Tension Member #100 has cracks located on the inside of pinhole that have propagated to the surface of the part. A 2' long seam crack was noted in the center plate area.

Figure 15. Defects Disclosed in Lower Chord Eye Bar 100 During Magnetic Particle Testing

Figure 16. Longitudinal Seams in Face of Lower Chord Eye Bar 100

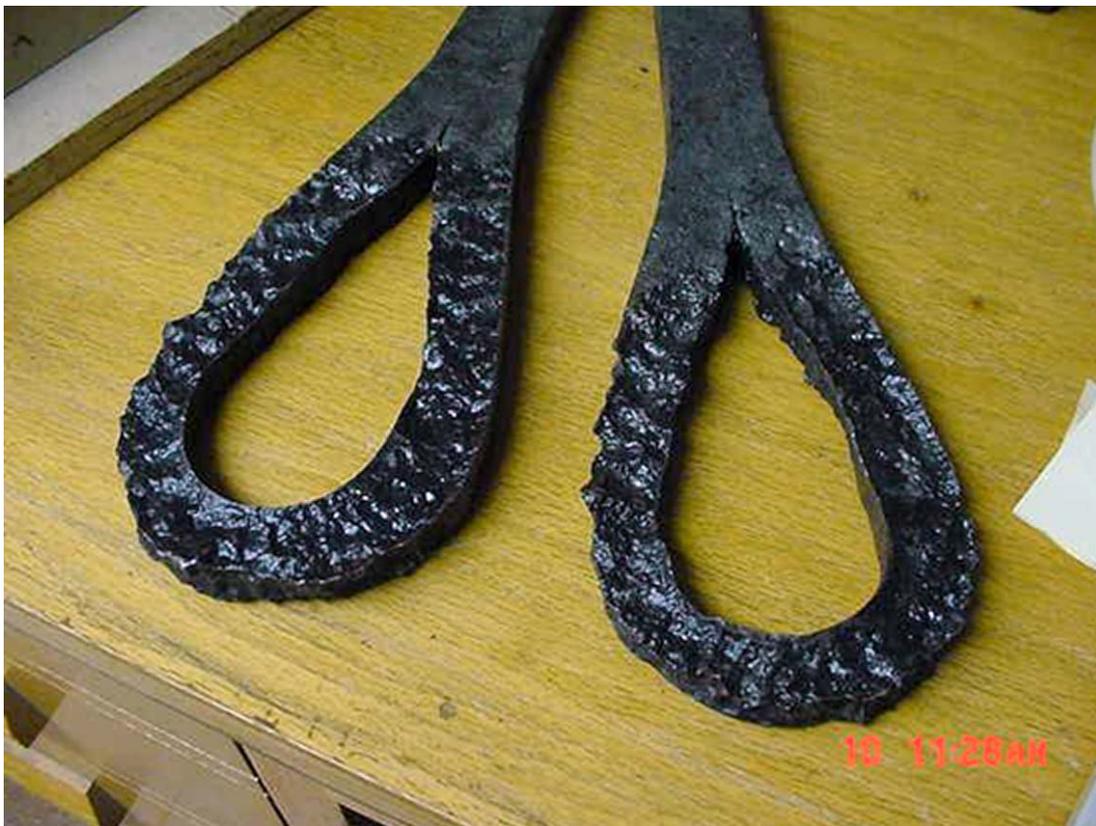
Figure 17. Typical Loop Bar Counters Showing Advanced Corrosion

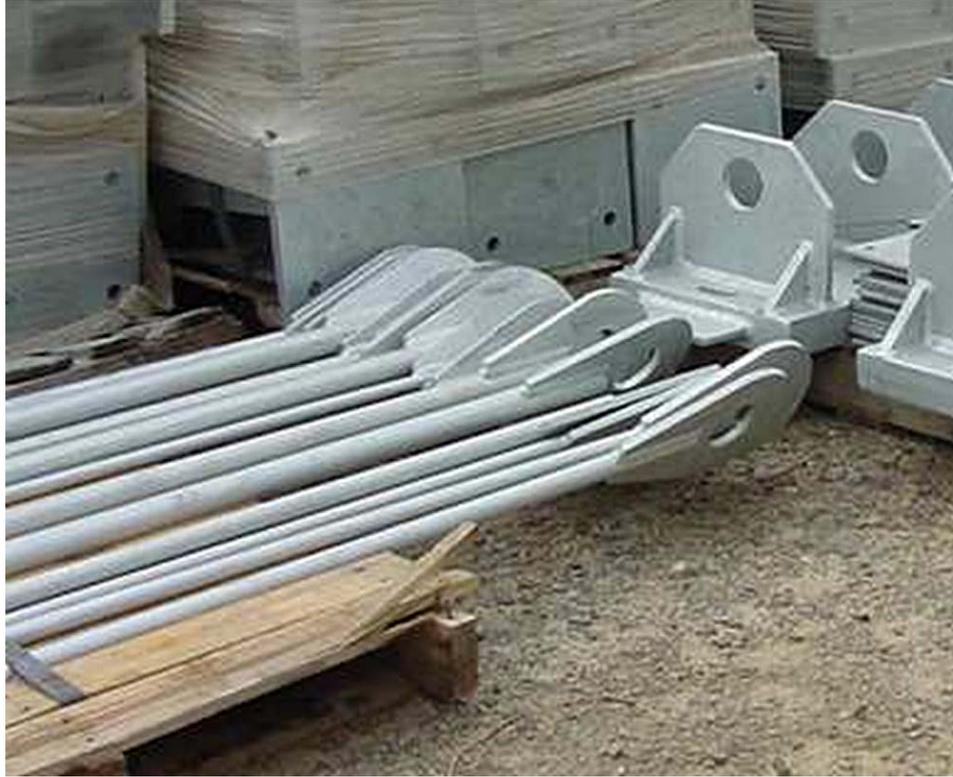
Figure 18. Replacement Counters

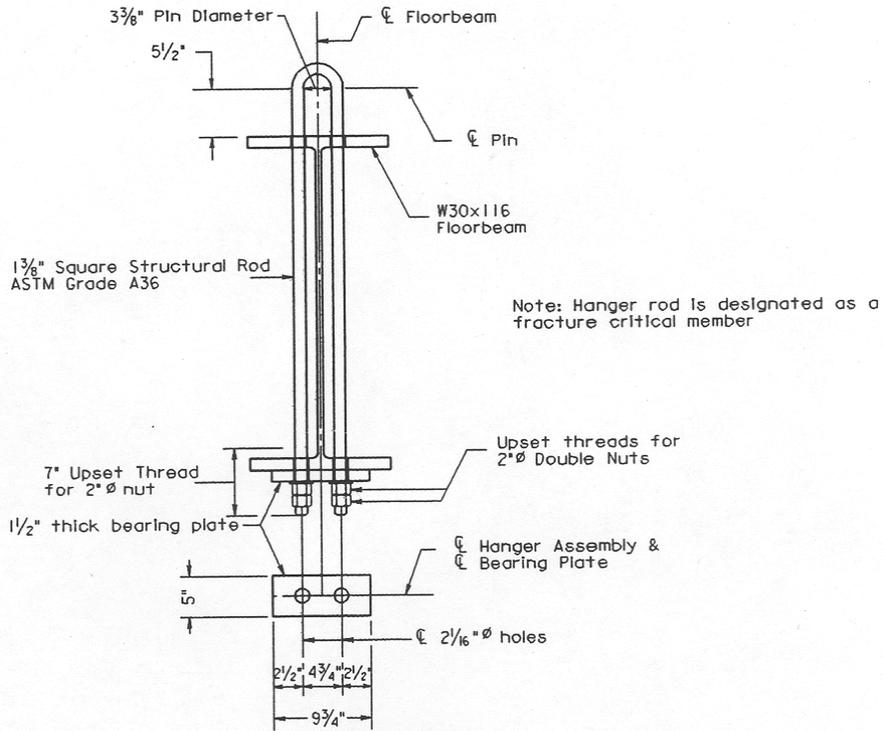
Figure 19. Replacement Truss Hanger Assembly

Replacement of the truss hanger assemblies (Figure 19), also designed as fracture-critical members, presented both a procurement and a fabrication problem. Details of the hanger, as shown in Figure 19, required the bending of a square bar (a round bar developed high bearing stresses) to fit around the pin, but one with a round cross-section with upset threads at its ends. Upset threads are those that extend beyond the outer dimensions of the bar, as opposed to being cut into the bar. Upset threads necessitate that the ends of the bar be round and of a diameter large enough to accommodate the threads. It was difficult to find a fabricator interested in producing the assemblies, which are not common today. The Haydon Bolt Company of Philadelphia produced the assembly by machining the central section of a 2-inch-diameter rod to produce a 1 $\frac{3}{8}$ -inch square bar with the required upset threads at its ends, cold bending it, heating it to relieve residual stresses, rebending it, and galvanizing it (Douthat, 2001).

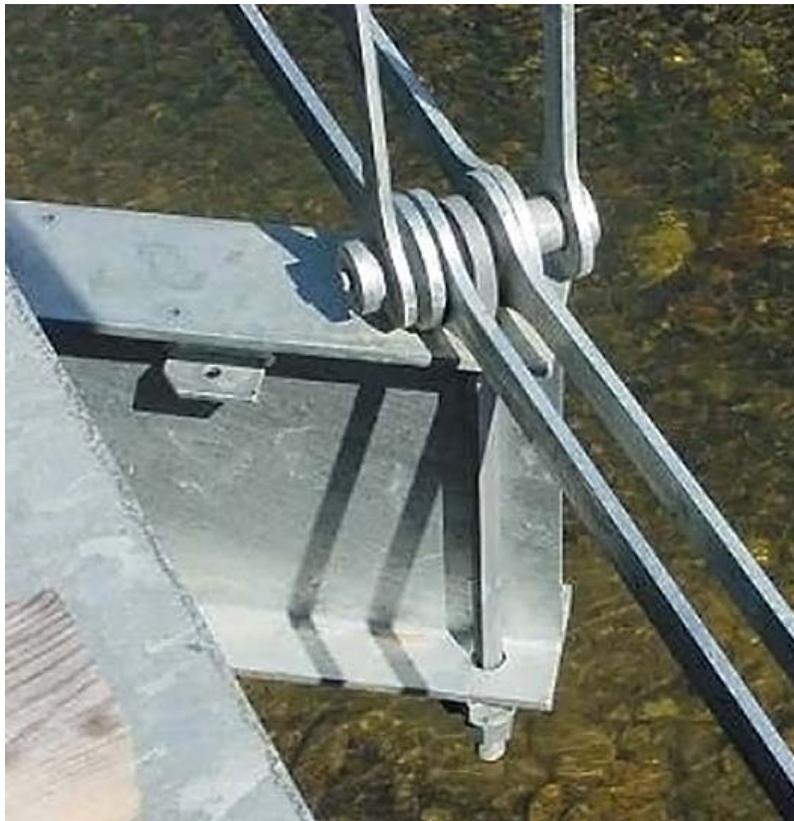
Figure 20. Final Truss Member Assembly at Lower Panel Point

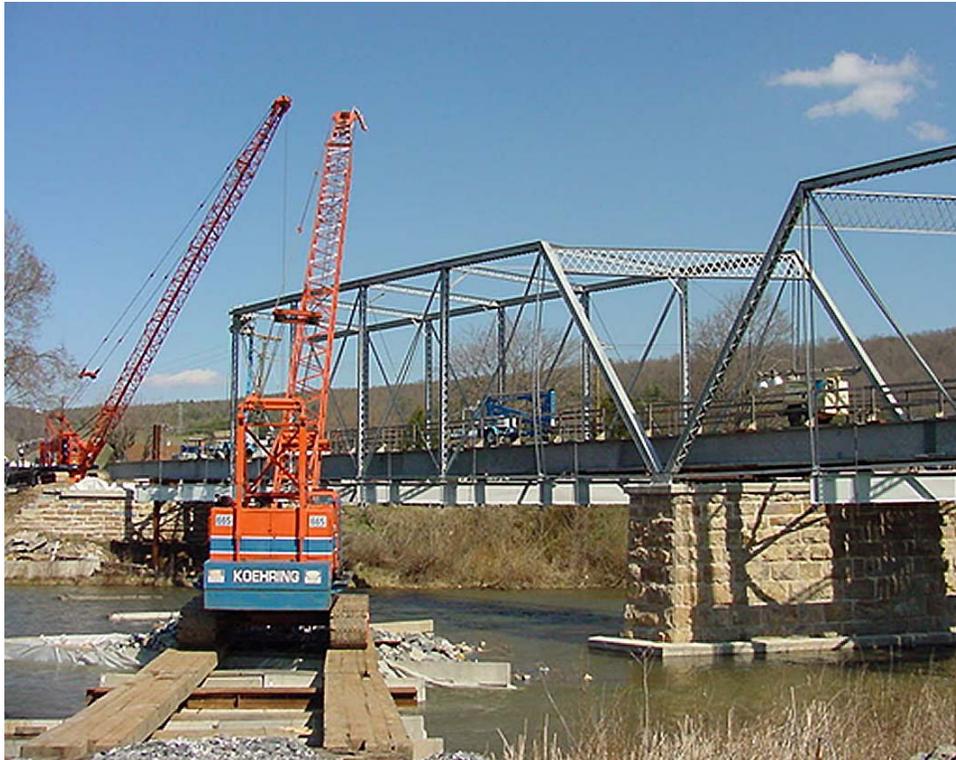
Figure 21. Crane Locations During Re-erection of Trusses

Negotiations with a private landowner to permit temporary access to those homes normally dependent on the Goshen Bridge allowed closure of the structure during its restoration. A temporary causeway was constructed in the river using concrete traffic barrier sections to support a deck of heavy timbers that was removed during periods of high water. Two cranes, one on the causeway and the other at the abutment nearest the work, were used during dismantling and re-erection (Figure 21).

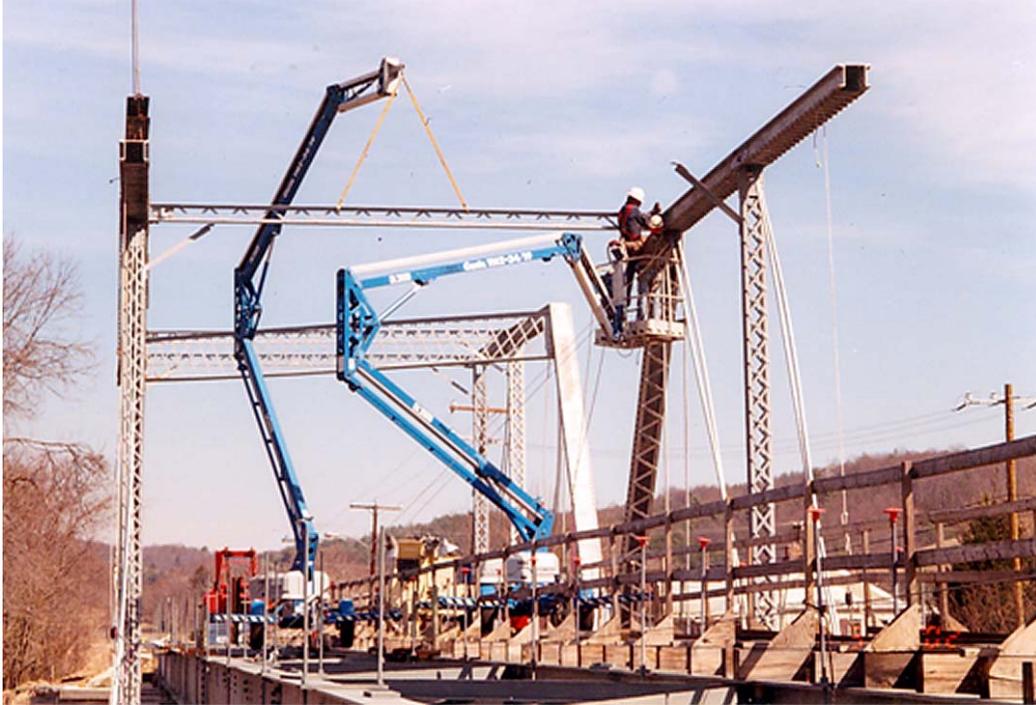
Figure 22. Light Electric Lifts During Re-Erection of Truss

Light electric-powered man lifts (Figure 22) were used for worker access and as light cranes on the bridge instead of the worker platform shown in Figure 9 during both dismantling and re-erection. Dismantling of the trusses could begin at either abutment, progressing from one span to the next, but re-erection began at the center pier and progressed outward to the abutments.

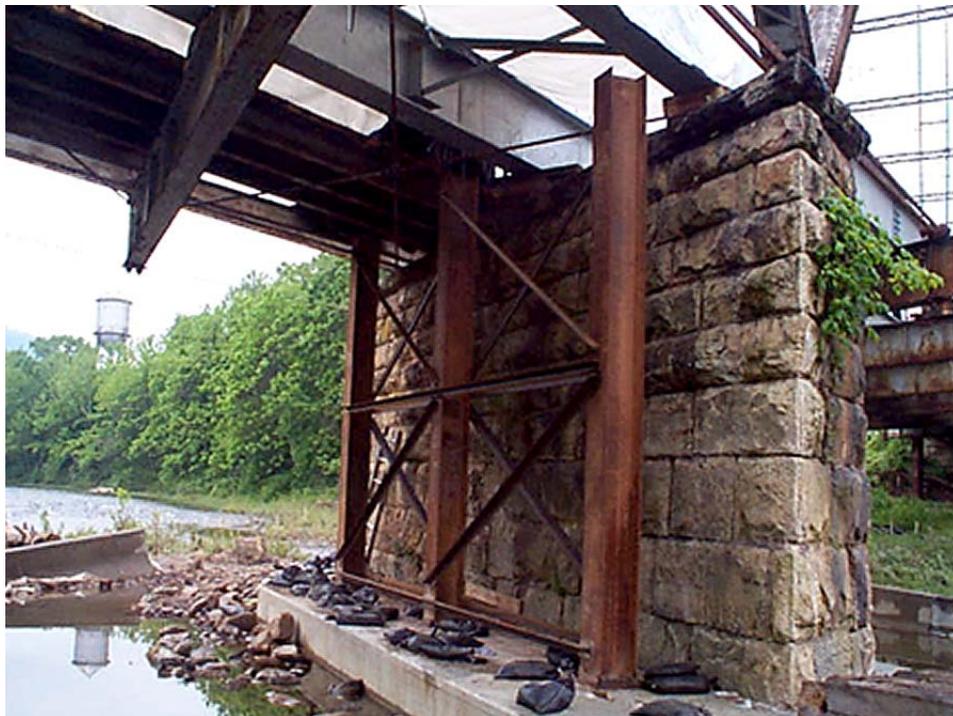
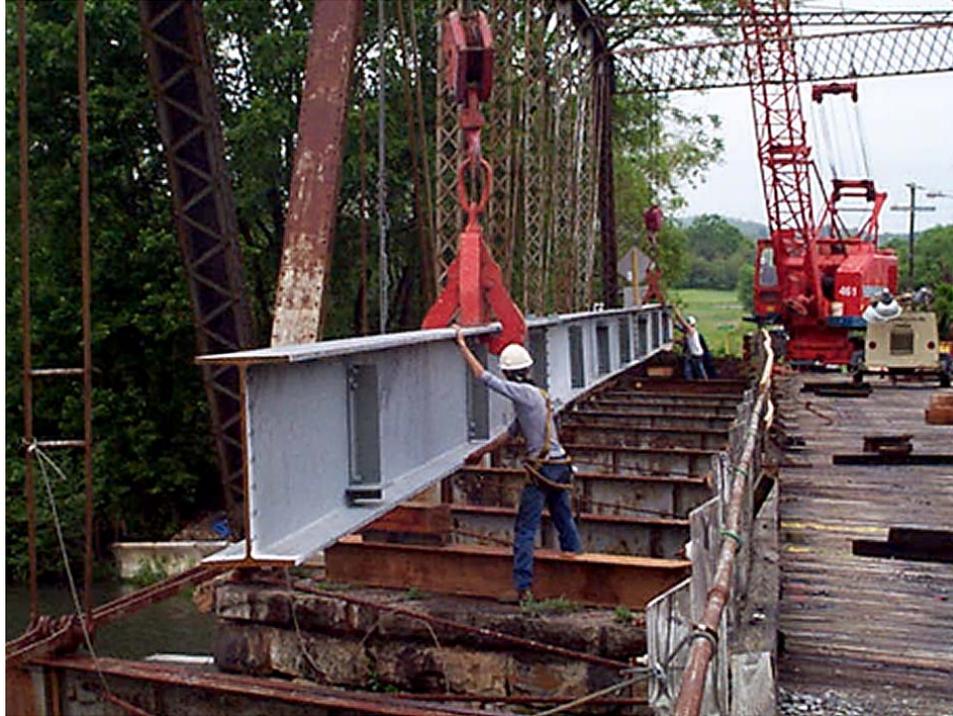
Figure 23. Falsework Bent at Pier with Two Lines of Falsework Beams in Place

Figure 24. Placing Falsework Beam

The three falsework bents (Figure 23), one at each abutment and the third at the center pier, were constructed before the falsework beams shown in Figure 24 were placed. Three H-piles on concrete footings founded on firm material (1.5 tons/square foot) supported the three lines of falsework beams, one pile beneath each beam. The footings were left in place and graded over upon completion of the project.

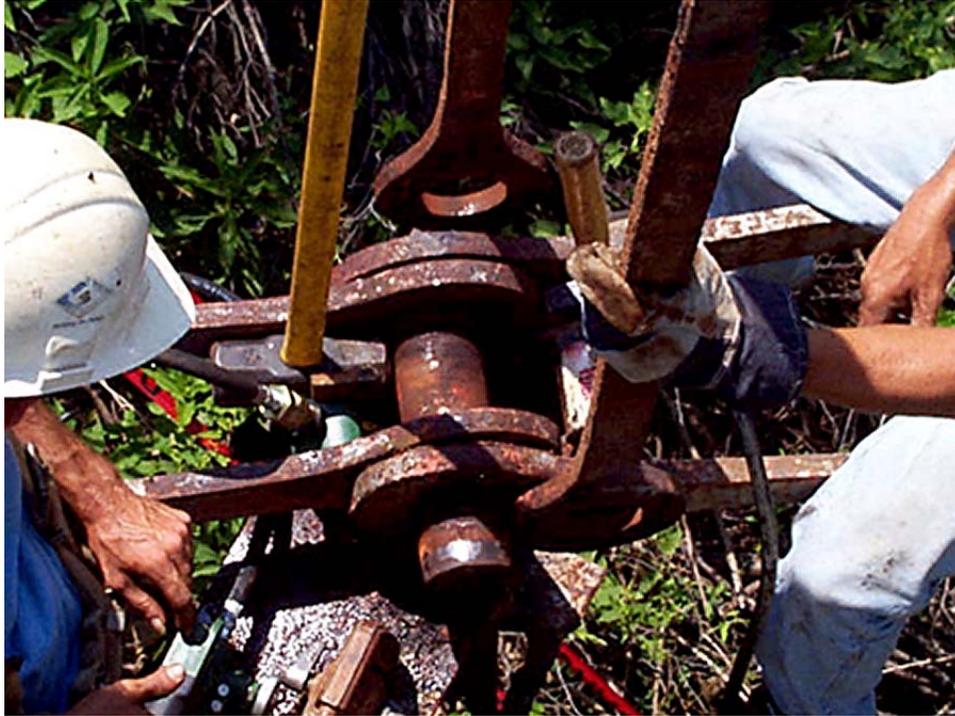
Figure 25. Jacking Truss Members Apart on Goshen Bridge

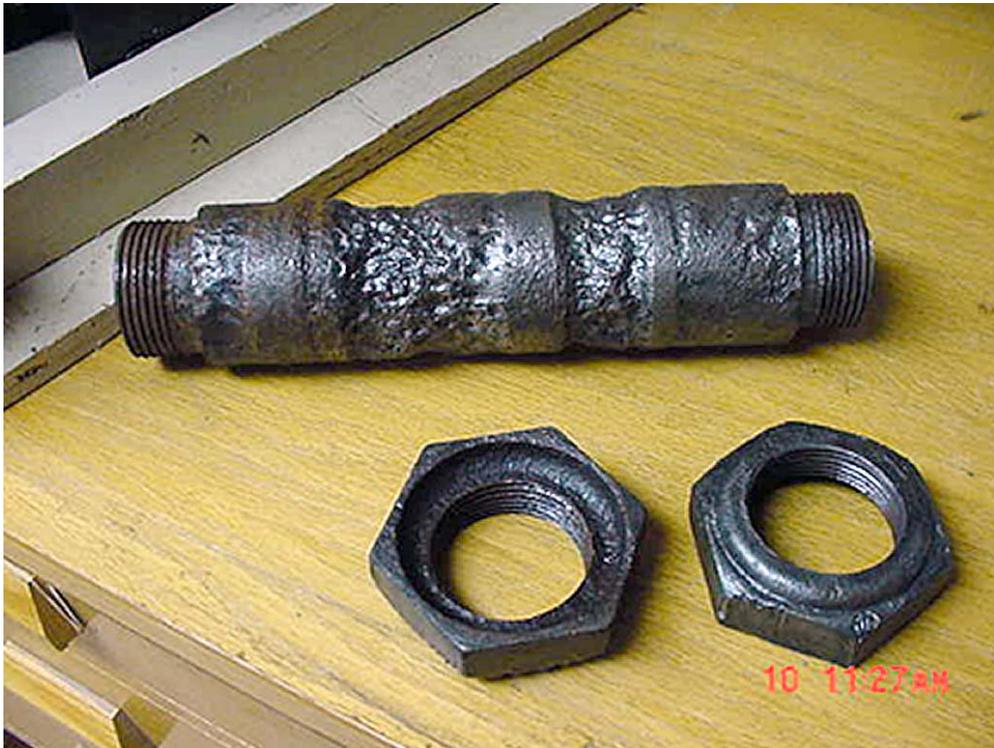
Figure 26. Heavily Corroded Pin; Section Loss Makes Removal Difficult

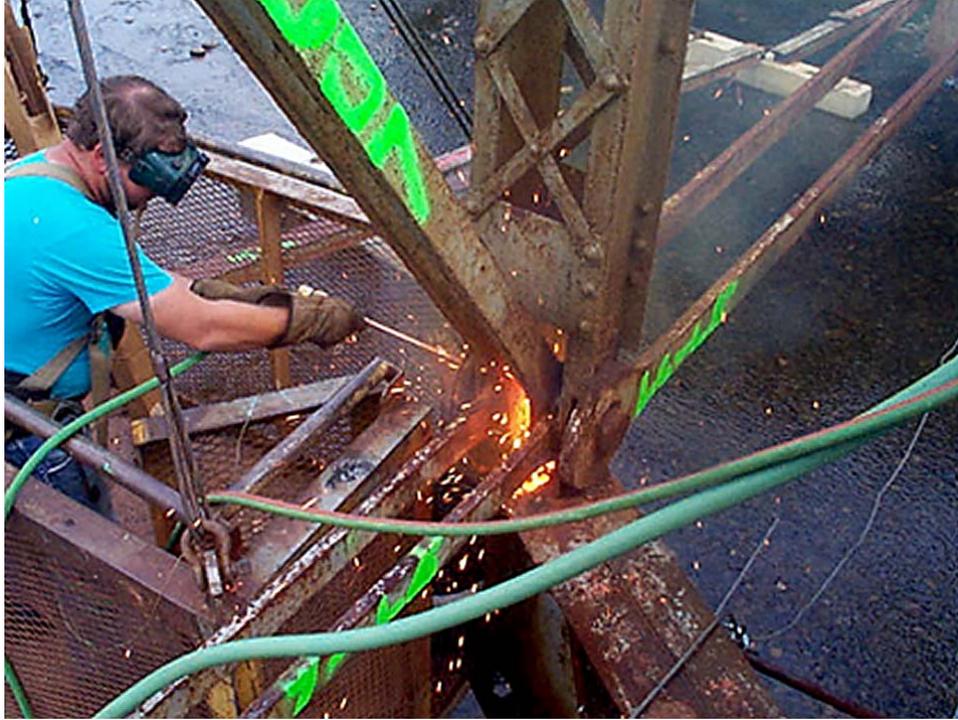
Figure 27. Piercing Center of Pin

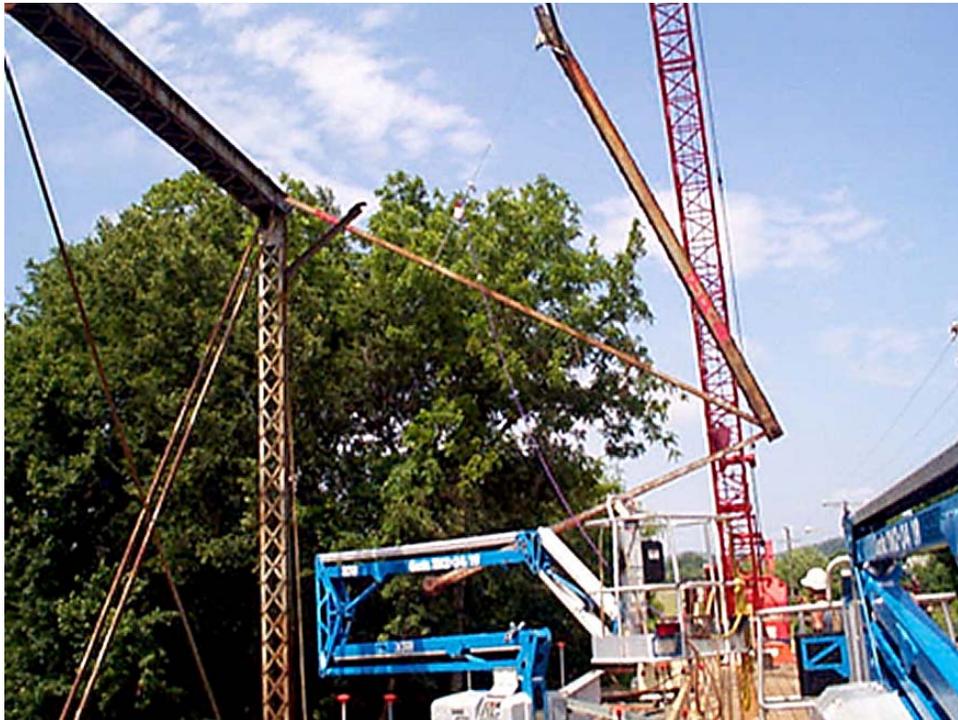
Figure 28. Cranes Remove Sections of Truss

The electric lifts shown earlier provided access to the panel points, allowing the dismantling of the trusses in sections composed of several members, as shown in Figure 28. Disassembly of the sections was completed elsewhere on the site. As shown in Figure 29, care was taken to support remaining members after the removal of pins. Those members selected for replacement were stored on sheeting at the site until the dimensions of their replacements were

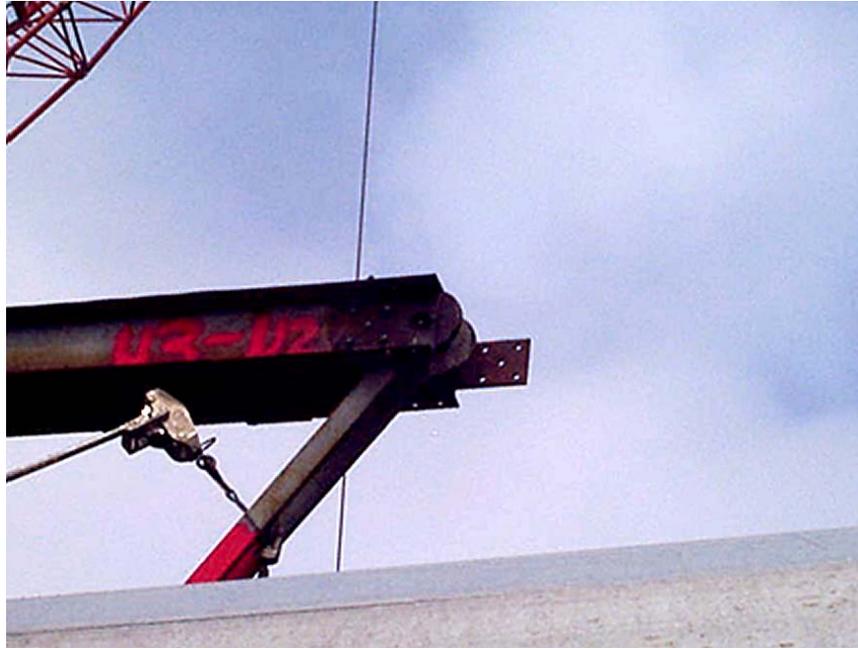
Figure 29. Supporting Diagonal After Pin Removal

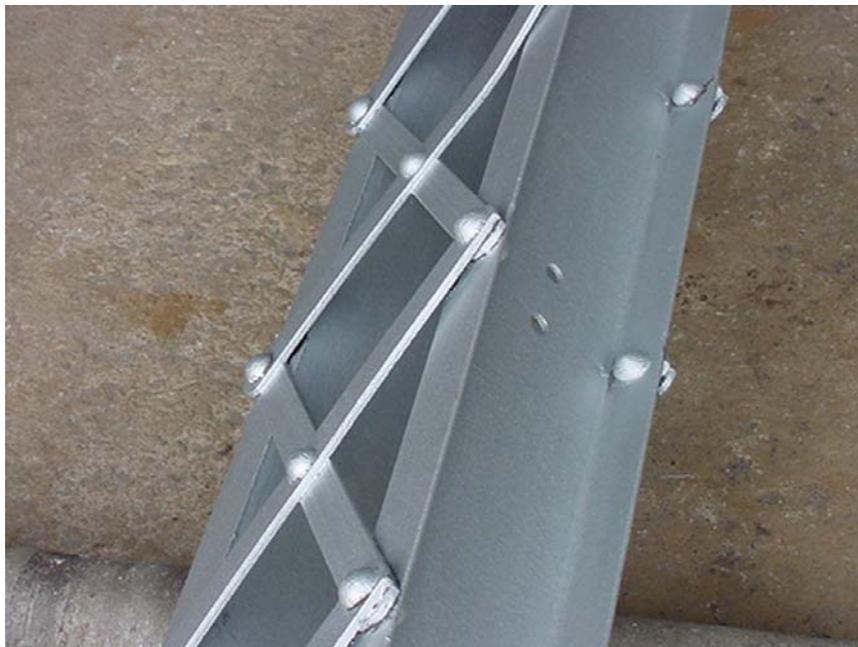
Figure 30. Original Vertical Member After Cleaning and Galvanizing

verified. The members to be retained were shipped to Galvan Industries of Harrisburg, North Carolina, for galvanizing. After sandblasting to remove lead paint, the members were further cleaned to remove oil and contaminants, and the surfaces prepared for the zinc coating. No disassembly of individual members was required. Some minor difficulty was experienced, at times, in achieving proper adhesion, but the final results obtained (Figure 30) promise excellent durability.

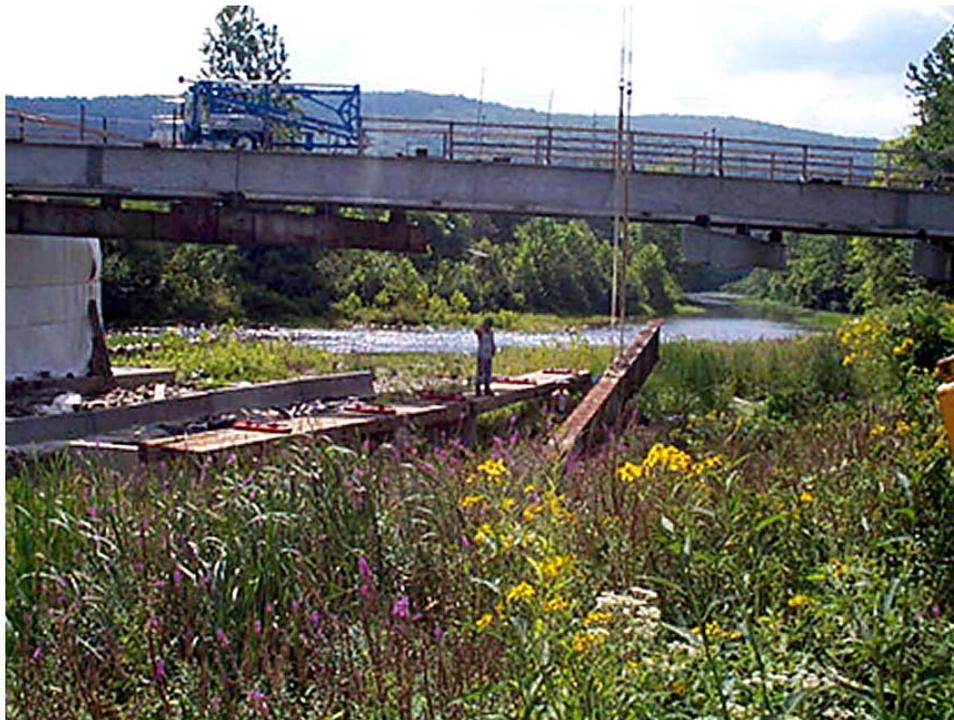
Figure 31. Floor Beam Replacement

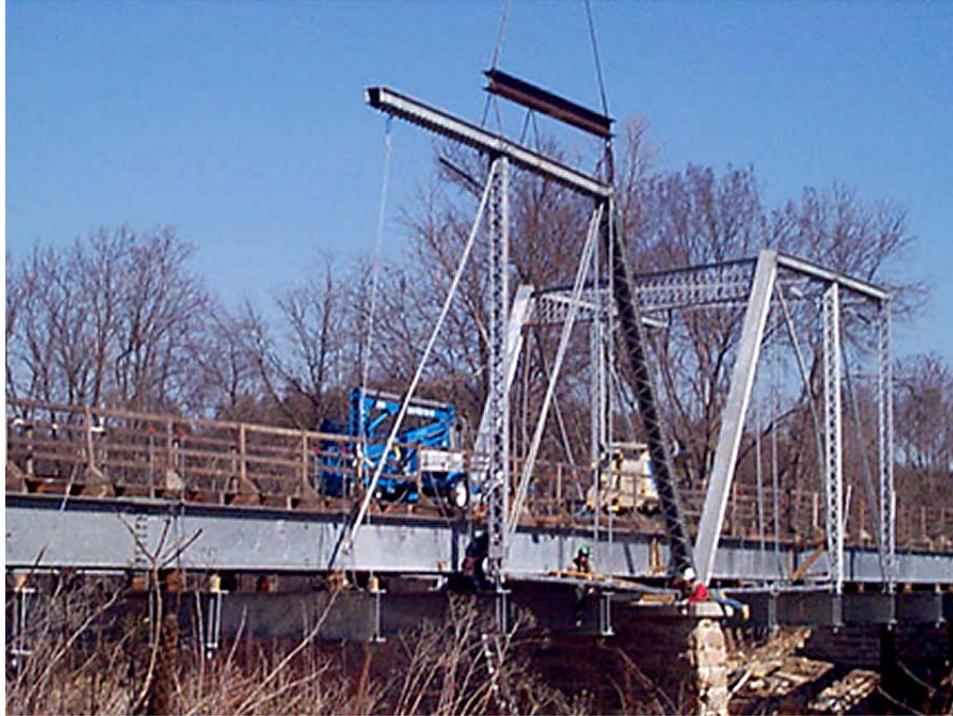
Figure 32. Re-erection of Trusses

As noted earlier, the use of an internal falsework beam system converted the two simply supported trusses into a two-span continuous structure. Thus, loads in one span will cause an upward deflection in the adjacent span. Balanced construction was necessary to maintain equal deflections, beginning at the center pier and progressing concurrently toward abutments, as shown in Figure 32. Construction can begin at the ends of the spans if falsework supports are located at each panel point.

Care must be taken during re-erection to ensure that the members are not only in their correct locations between panel points on the truss but also in their proper positions on the pins at the panel points. Photographs of the proper orientation of members in the joints were provided to the inspector. Placing the pins can be an intricate process requiring manipulation of the truss with the cranes and jacks and the use of lubricants. Driving the pins was permitted on the Goshen Bridge, but the use of a rubber hammer was required to protect the galvanizing. Members and pins had been detailed to allow for the thickness of the coating.
