FINAL REPORT
VTRC 06-R31

BEST PRACTICES FOR THE REHABILITATION AND MOVING OF HISTORIC METAL TRUSS BRIDGES

Figure 1. Route 746 Bridge Over Calfpasture River at Goshen, Virginia

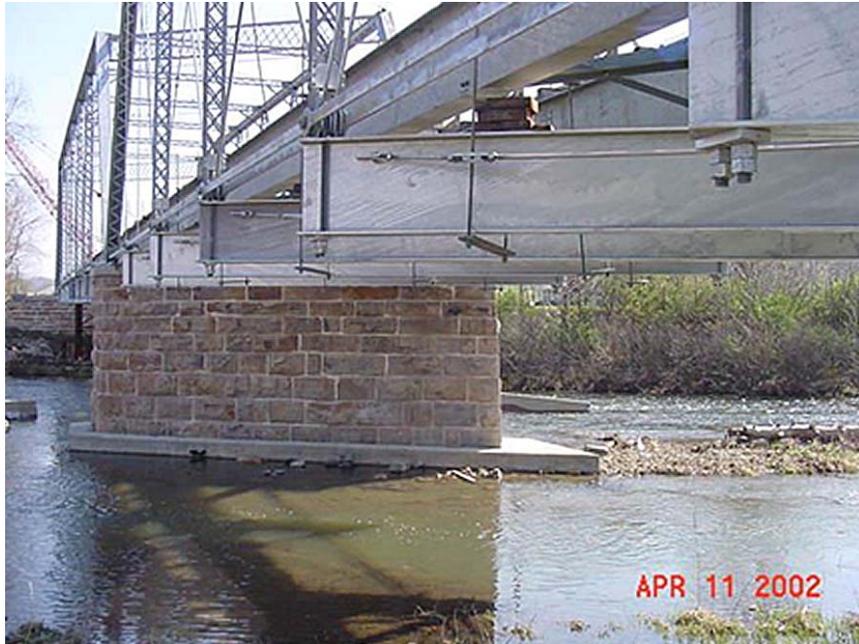
Figure 33. Loosened Falsework Hangers at Completion of Truss Erection

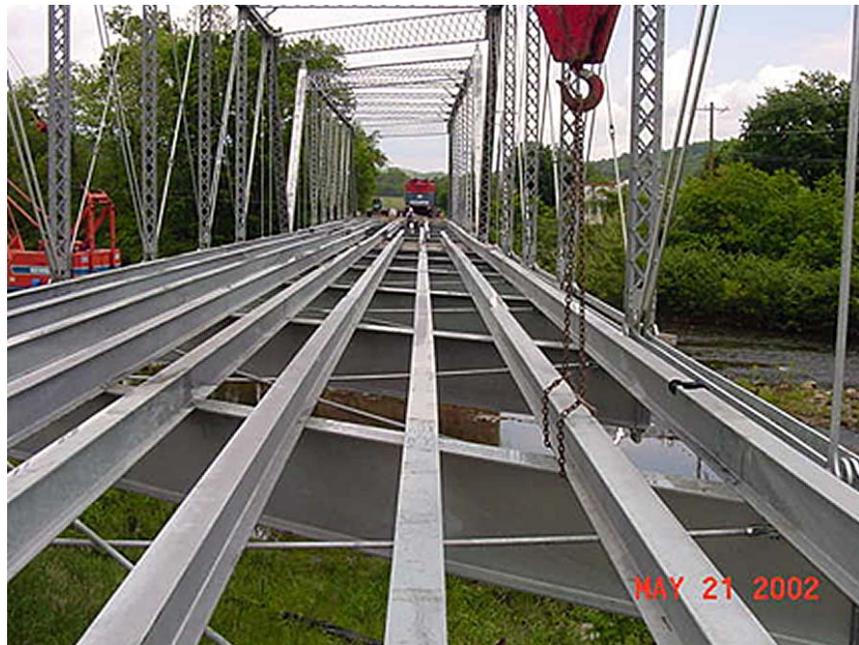
Figure 34. Installation of Stringers

The falsework beams were removed after the transfer of loads to the trusses, and the stringers (Figure 34), glued laminated timber deck panels (Figure 35), and rail system (Figure 36) were installed. Final grading to the original contours and the placement of a repainted plaque and new decorative spires completed the refurbishing of the Goshen Bridge shown in Figure 37. There are plans to place a bronze tablet near the bridge to note the date of its restoration and to credit the entities that contributed to its successful restoration.

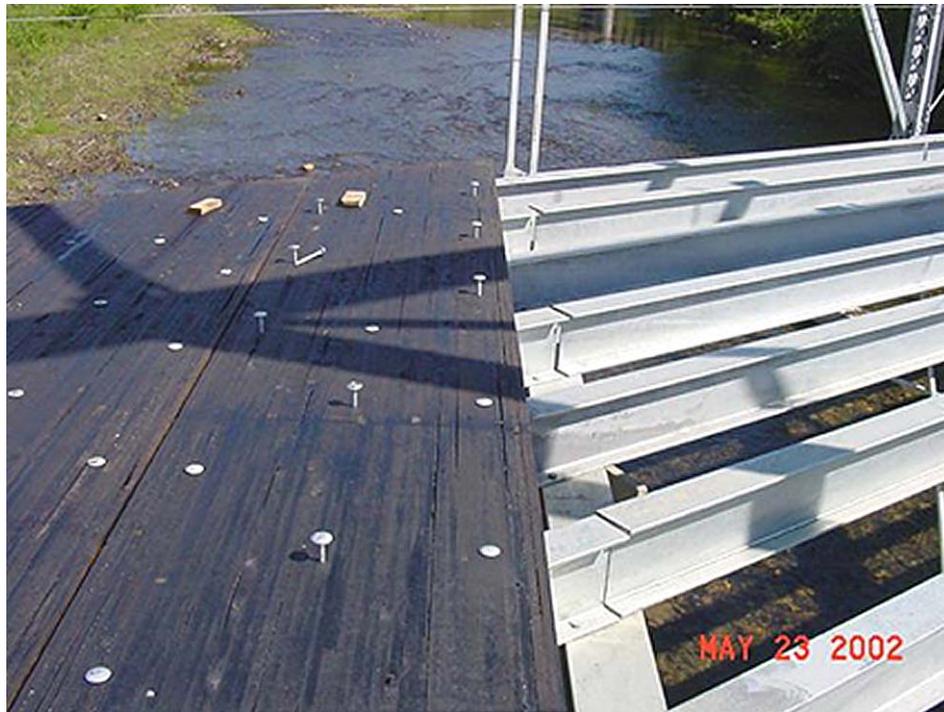
Figure 35. Glued Laminated Timber Panel Installation

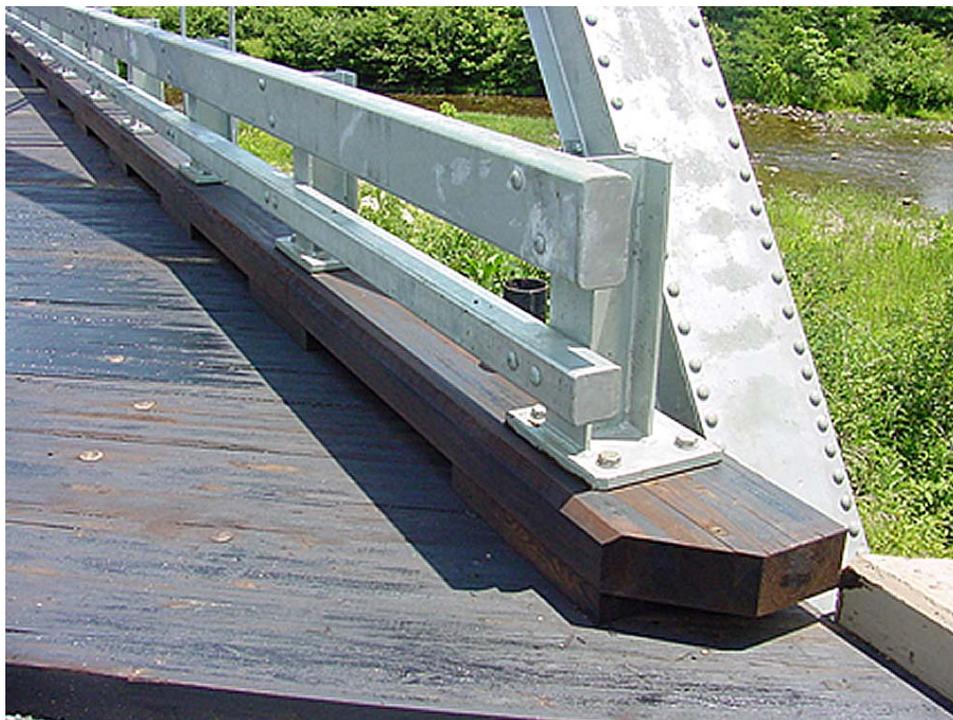
Figure 36. Modified Illinois Rail Protects Truss

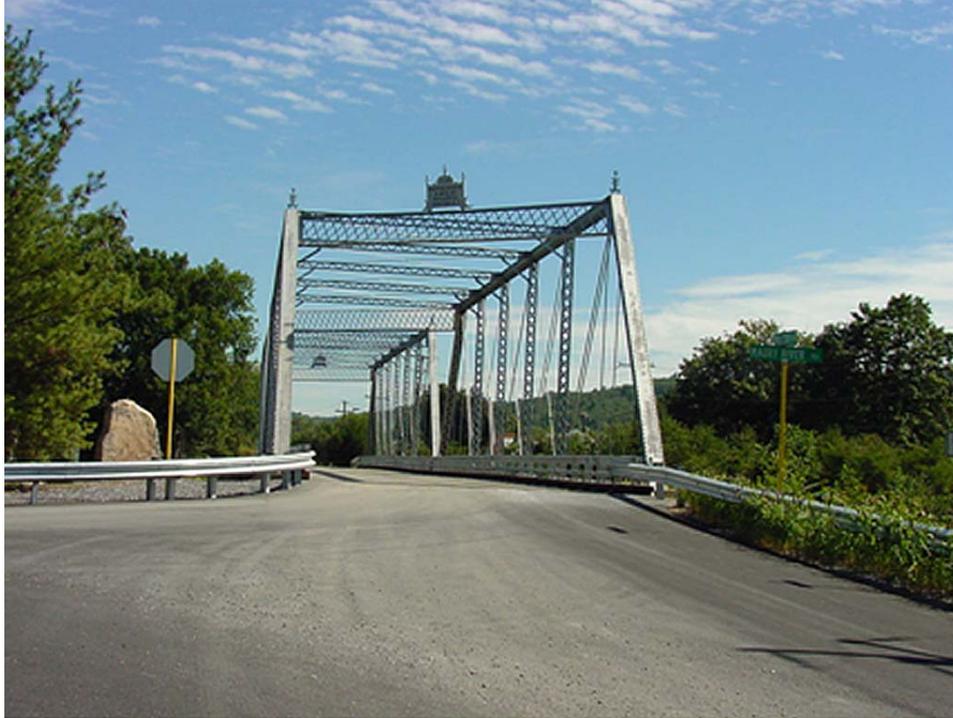
Figure 37. Rehabilitated Goshen Bridge, 2002

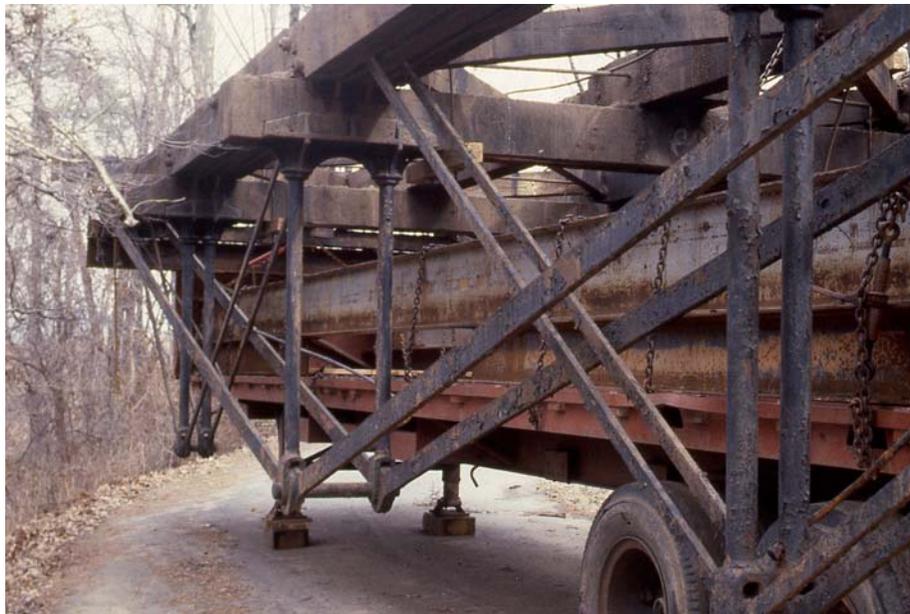
Figure 39. Moving Fink Truss

Virginia's rare Fink deck truss bridge (Figure 38) cited earlier in this report was taken out of service and moved after removal of its deck and railings (Figure 39) from its site over a railroad to a nearby park (Figure 40). The structure, which was 52 feet, 6 inches long by 13 feet wide by 7 feet, 6 inches deep was supported on stanchions on a flat bed trailer to avoid disassembling the truss members.

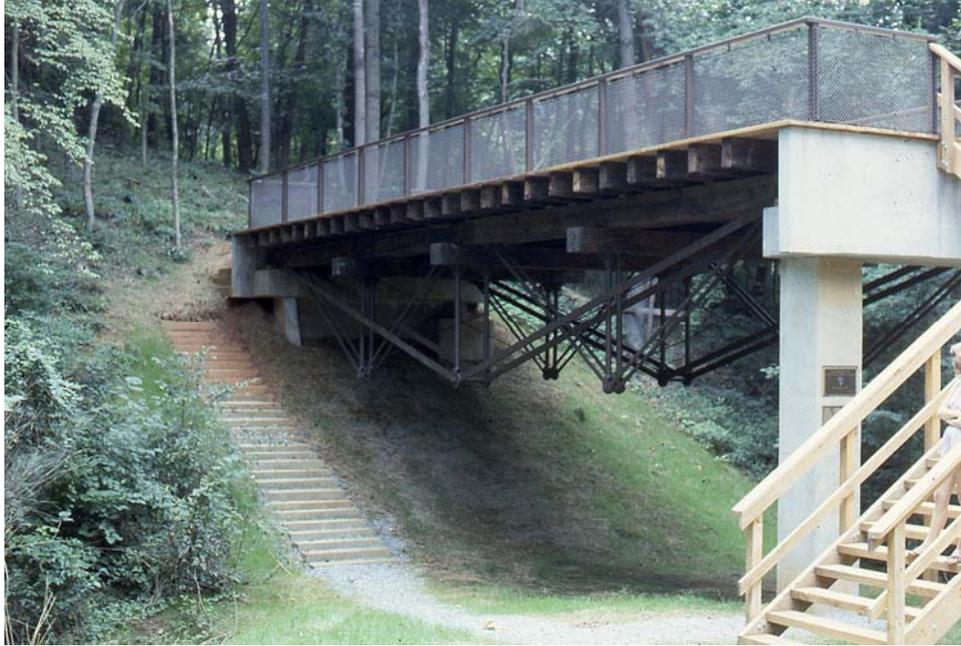
Figure 40. Fink Truss as Exhibit in Park

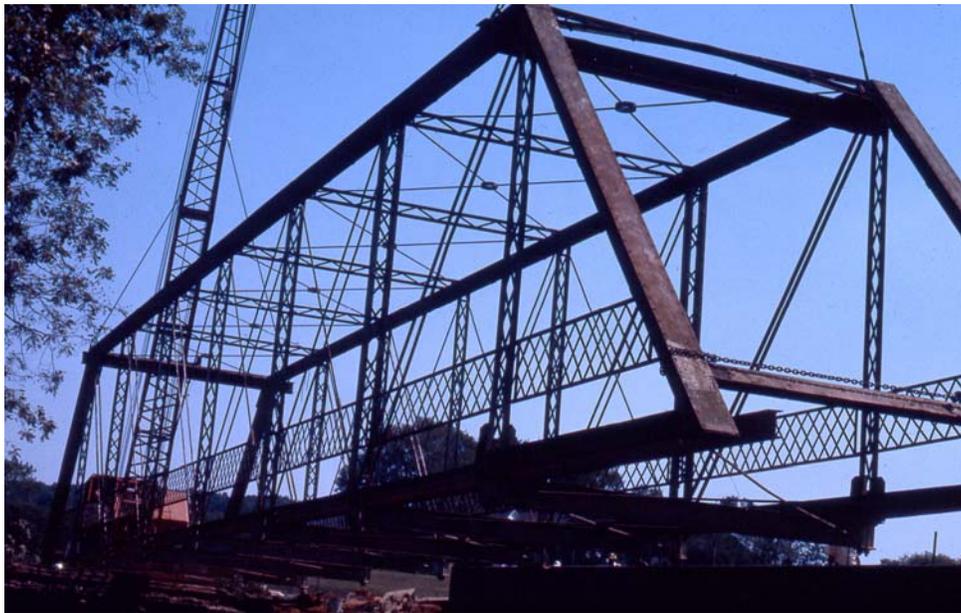
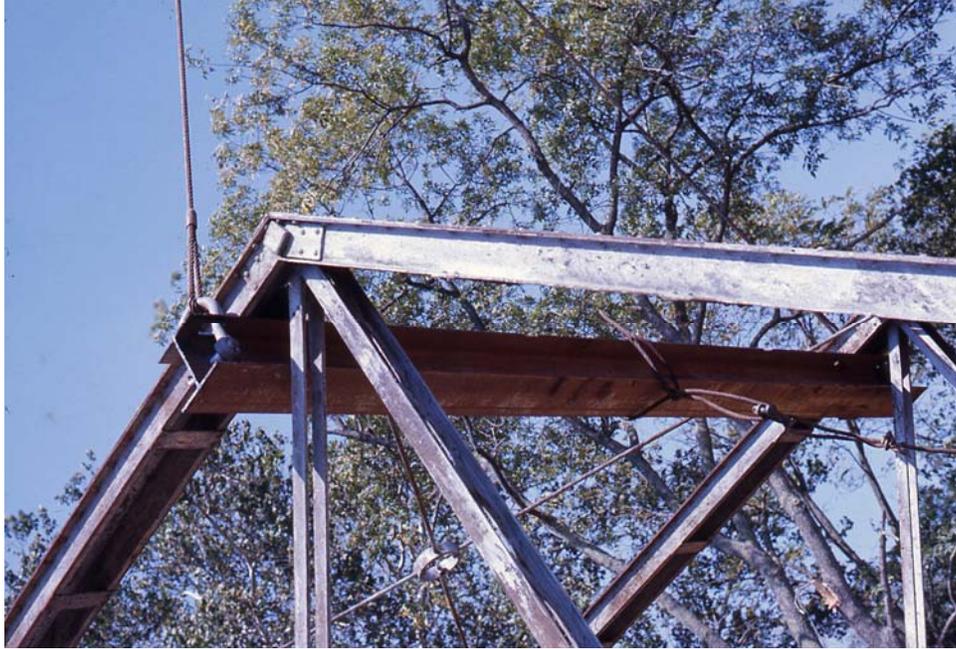
Figure 41. Lifting 106-foot Pratt Truss

Figure 42. Lifting Apparatus at Hip Joint, 106-foot Truss

A larger Pratt through-truss bridge, 106 feet in length, built over the Rappahannock River in 1879 by the King Iron Bridge and Manufacturing Company of Cleveland, Ohio (Figure 41), was lifted from its bearing using two cranes and placed nearby for dismantling. Surveyed in 1974, it was in "imminent threat of replacement" (Diebler, 1975). Its deck was removed, and lifting points (Figure 42) were placed at the hip joints. Lower chord tension members required reinforcement by the addition of temporary struts to sustain compressive forces generated during lifting.

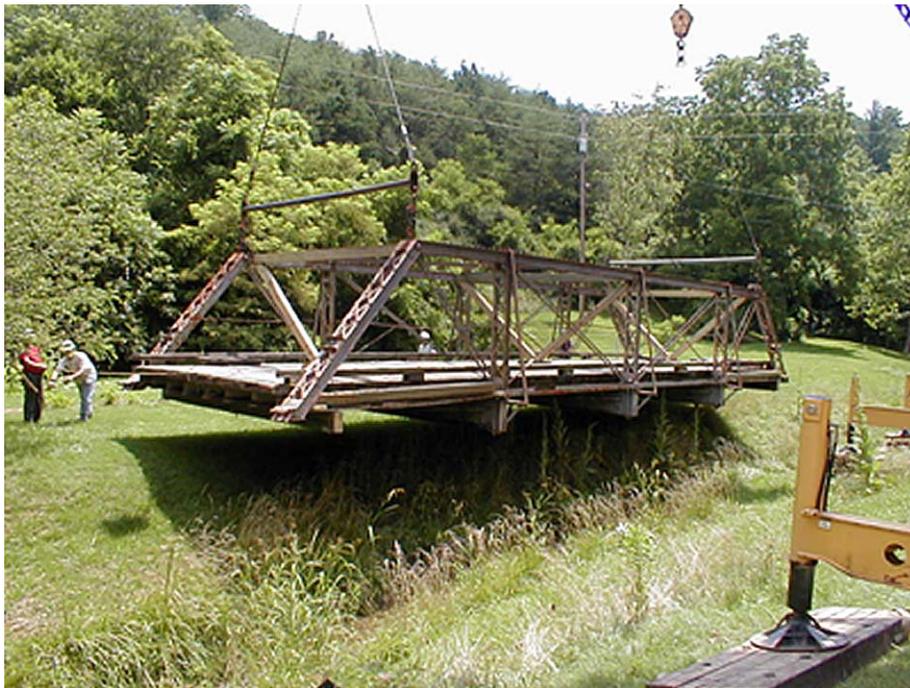
Figure 43. Moving Pony Truss Bridge

Supplemental struts for the lower chord members and between the trusses were required for stability when the light pony truss shown in Figure 43 was moved. Lifting a bridge by attachments at the hip joints induces compressive forces in the lower chords of the end panels.
